Town of Friday Harbor Watershed

Trout Lake Forest Assessment

10/21/2019

CROWNFIRE FOREST PLANNING, LLC.

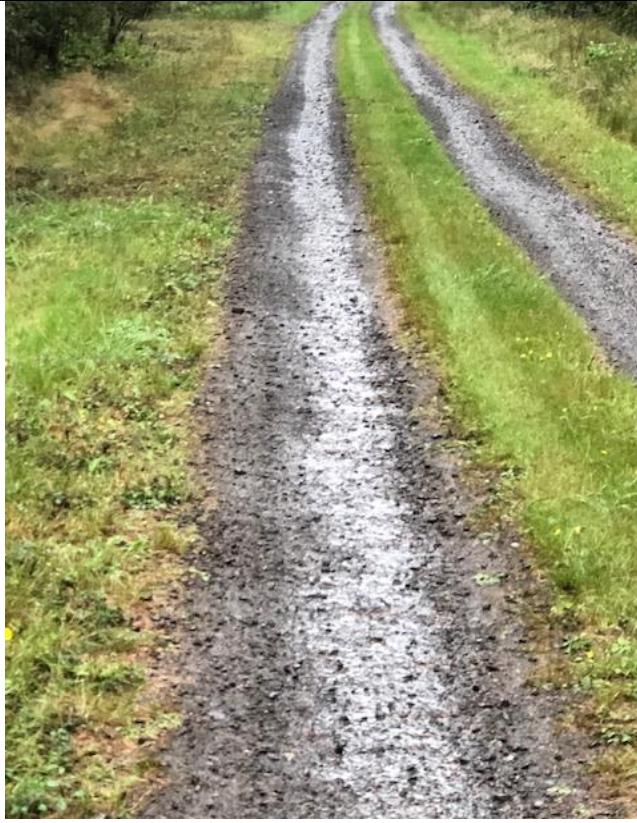
- 1) Mainline roads are in reasonably good condition. They do show wear in the wheel tracks, developing channeling of storm water. Berms exist along most ditches resulting in keeping storm water on the roads, which leads to increased washing or road surface fines.

Photo top of hill looking east on access road shows channeling of storm water and worn wheel tracks	Phot shows road damage, ditch line failure, culvert failure at main road junctions with pump site access

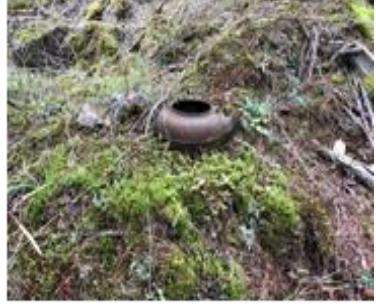
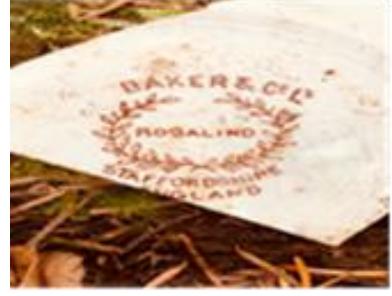
Cooking debris from cabin site	China ware from cabin site

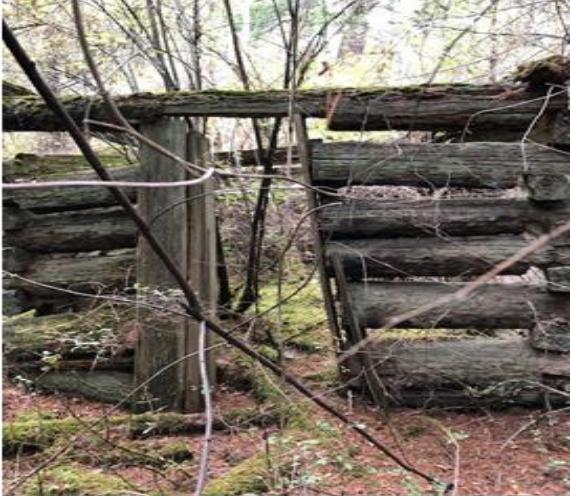
A small dilapidated standing log structure, and household debris, typical of a historic cabin site, is located just north of the mainline and west of the access gate.

Possible historic cabin north of access road in area of pump house	Savanah type forest setting in rock outcrop areas, higher elevations in stand 1. Approximately 10 trees should be removed from this area. Old forest stump's spaced +/- 60'

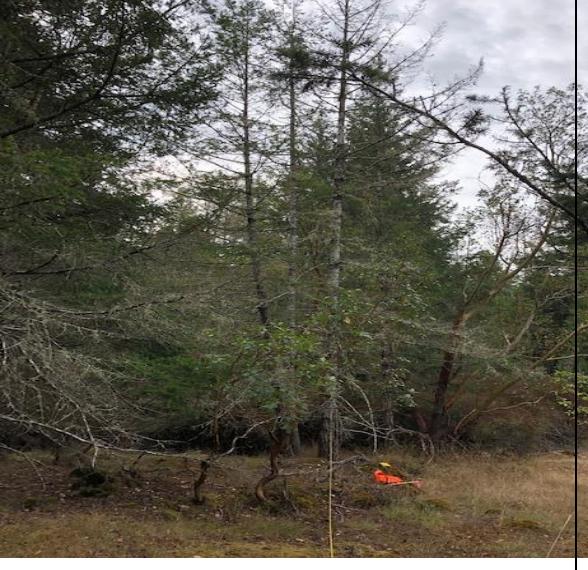
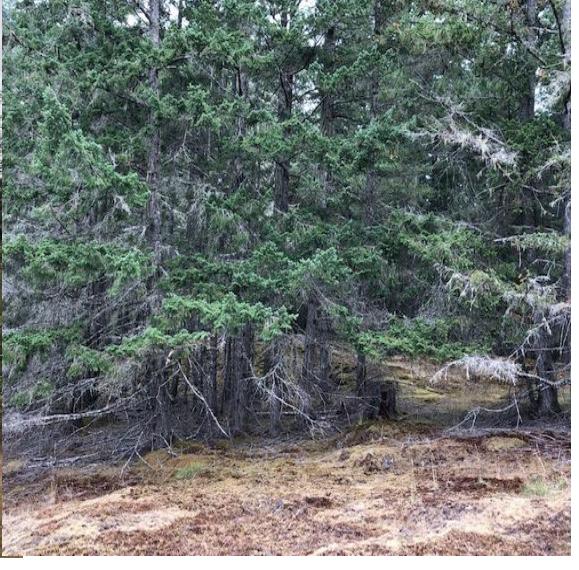
Photos showing in fill of smaller DF along edges of out crops and balds.

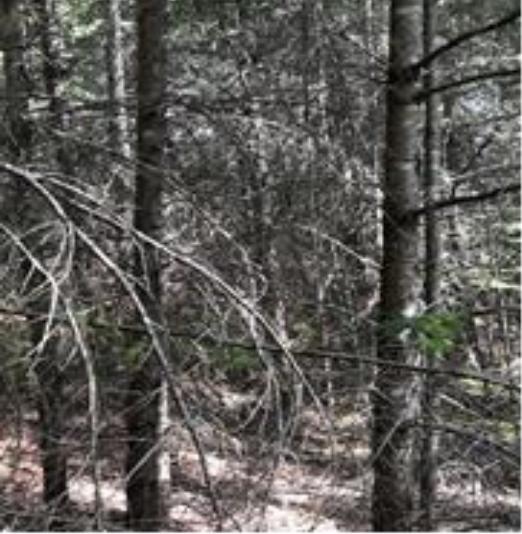
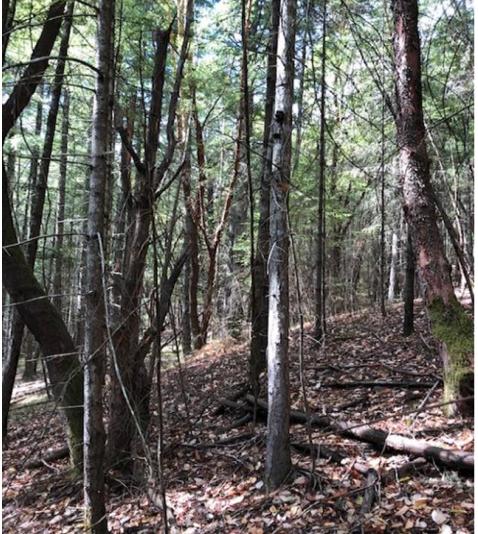
<p>Photo of 30 year old trees naturally seeded after a timber harvest. Small area north edge of ownership. Also a trail in this area running east/west to non-ownership.</p> <p>Typical patch of younger fir impacted with competition from madrone. Type of stand would need pre-commercial thinning to release DF. Small areas, less than one acre in size.</p>

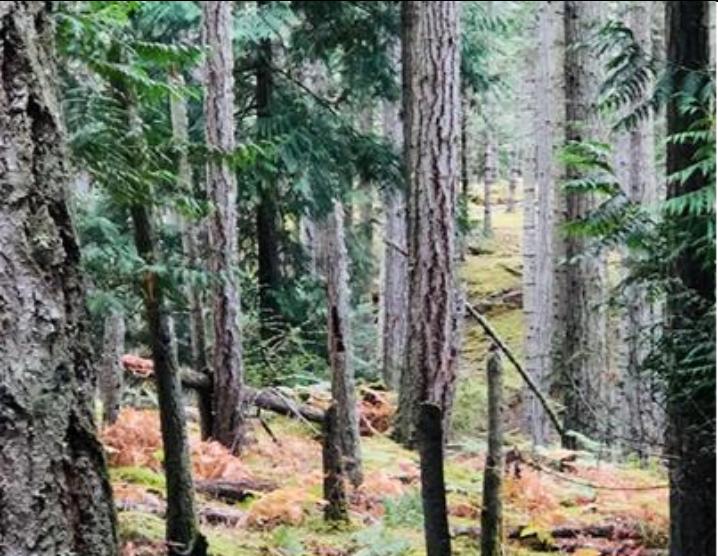
<p>Typical forest stand; area north of Dallas Mountain access. Note broken stems typical of several steam rots noted in forest health section. Approximately 9 trees should be removed from the near portion of the photo.</p>
